**ROYAL OAKS LANDFILL
CHEROKEE COUNTY, TEXAS
TCEQ PERMIT NO. MSW-1614B**

MAJOR PERMIT AMENDMENT APPLICATION

VOLUME 2 OF 7

PART III – SITE DEVELOPMENT PLAN

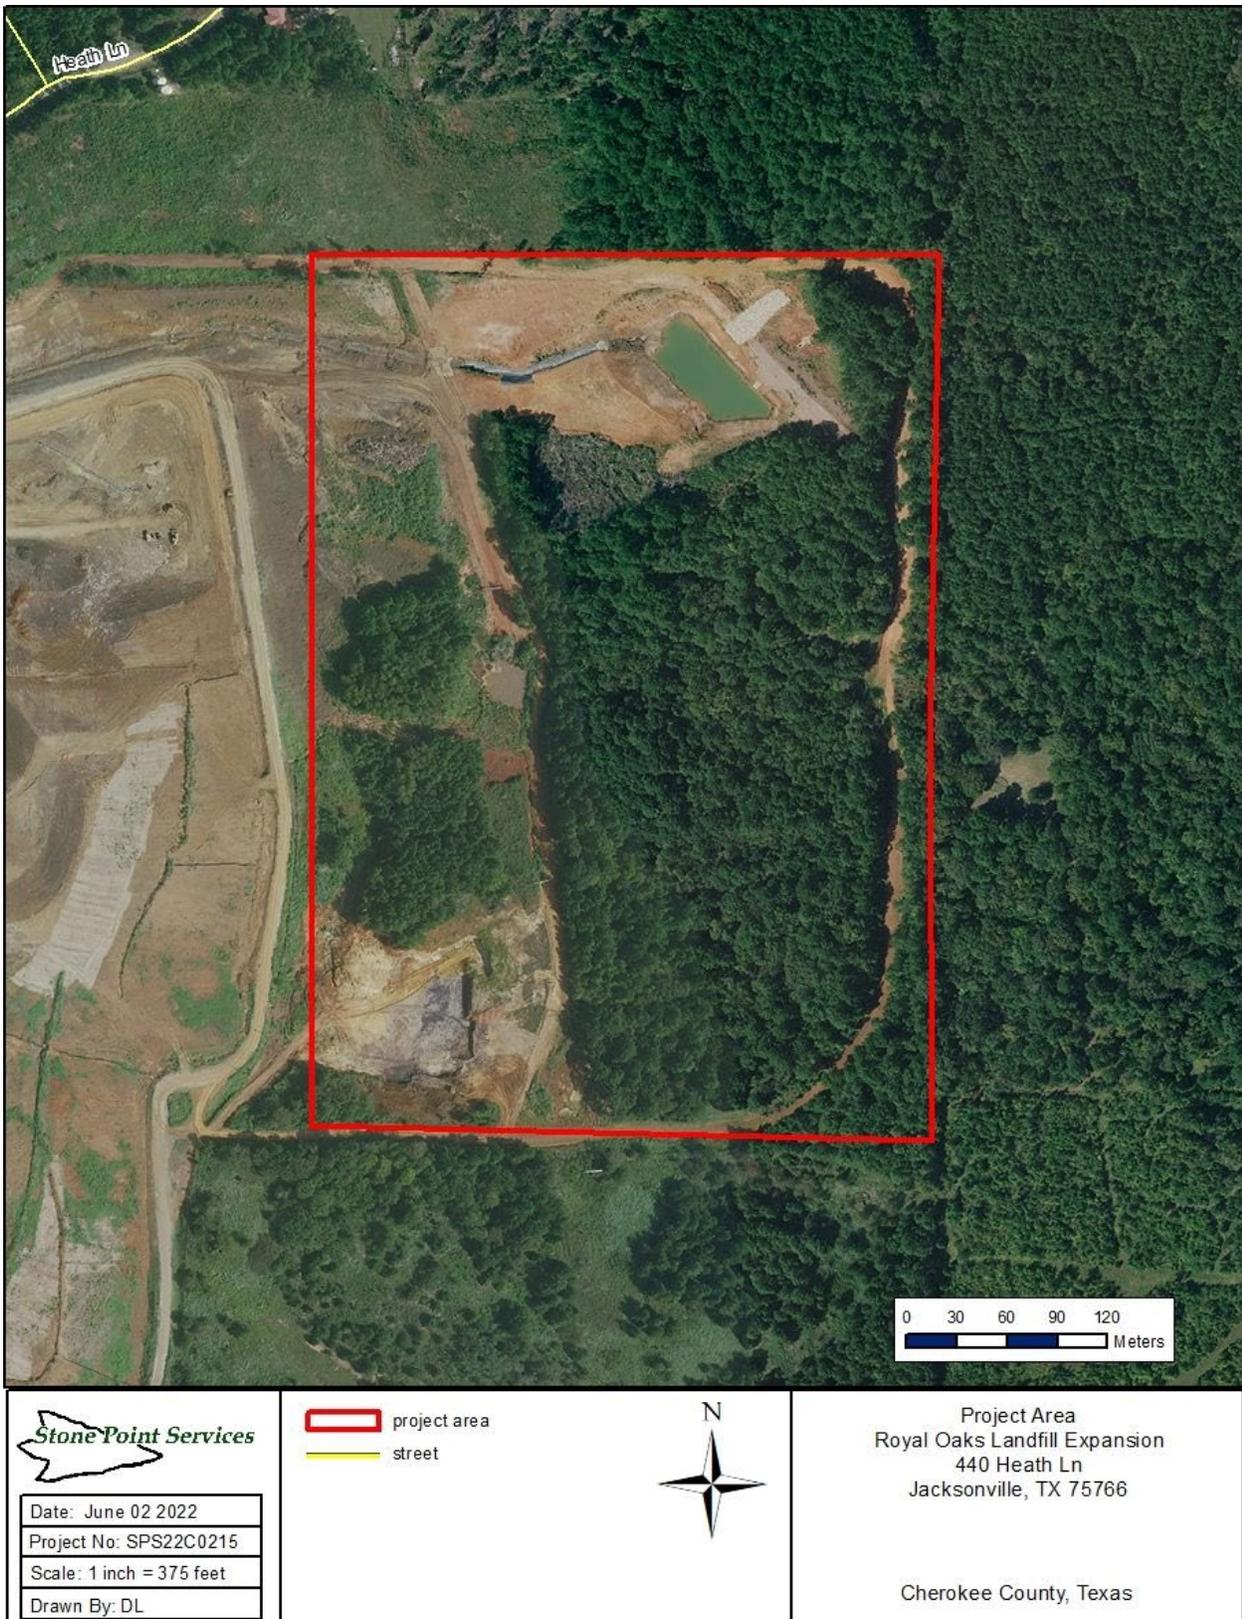
Figure 4: Construction area for the proposed Royals Oaks Landfill Expansion project.

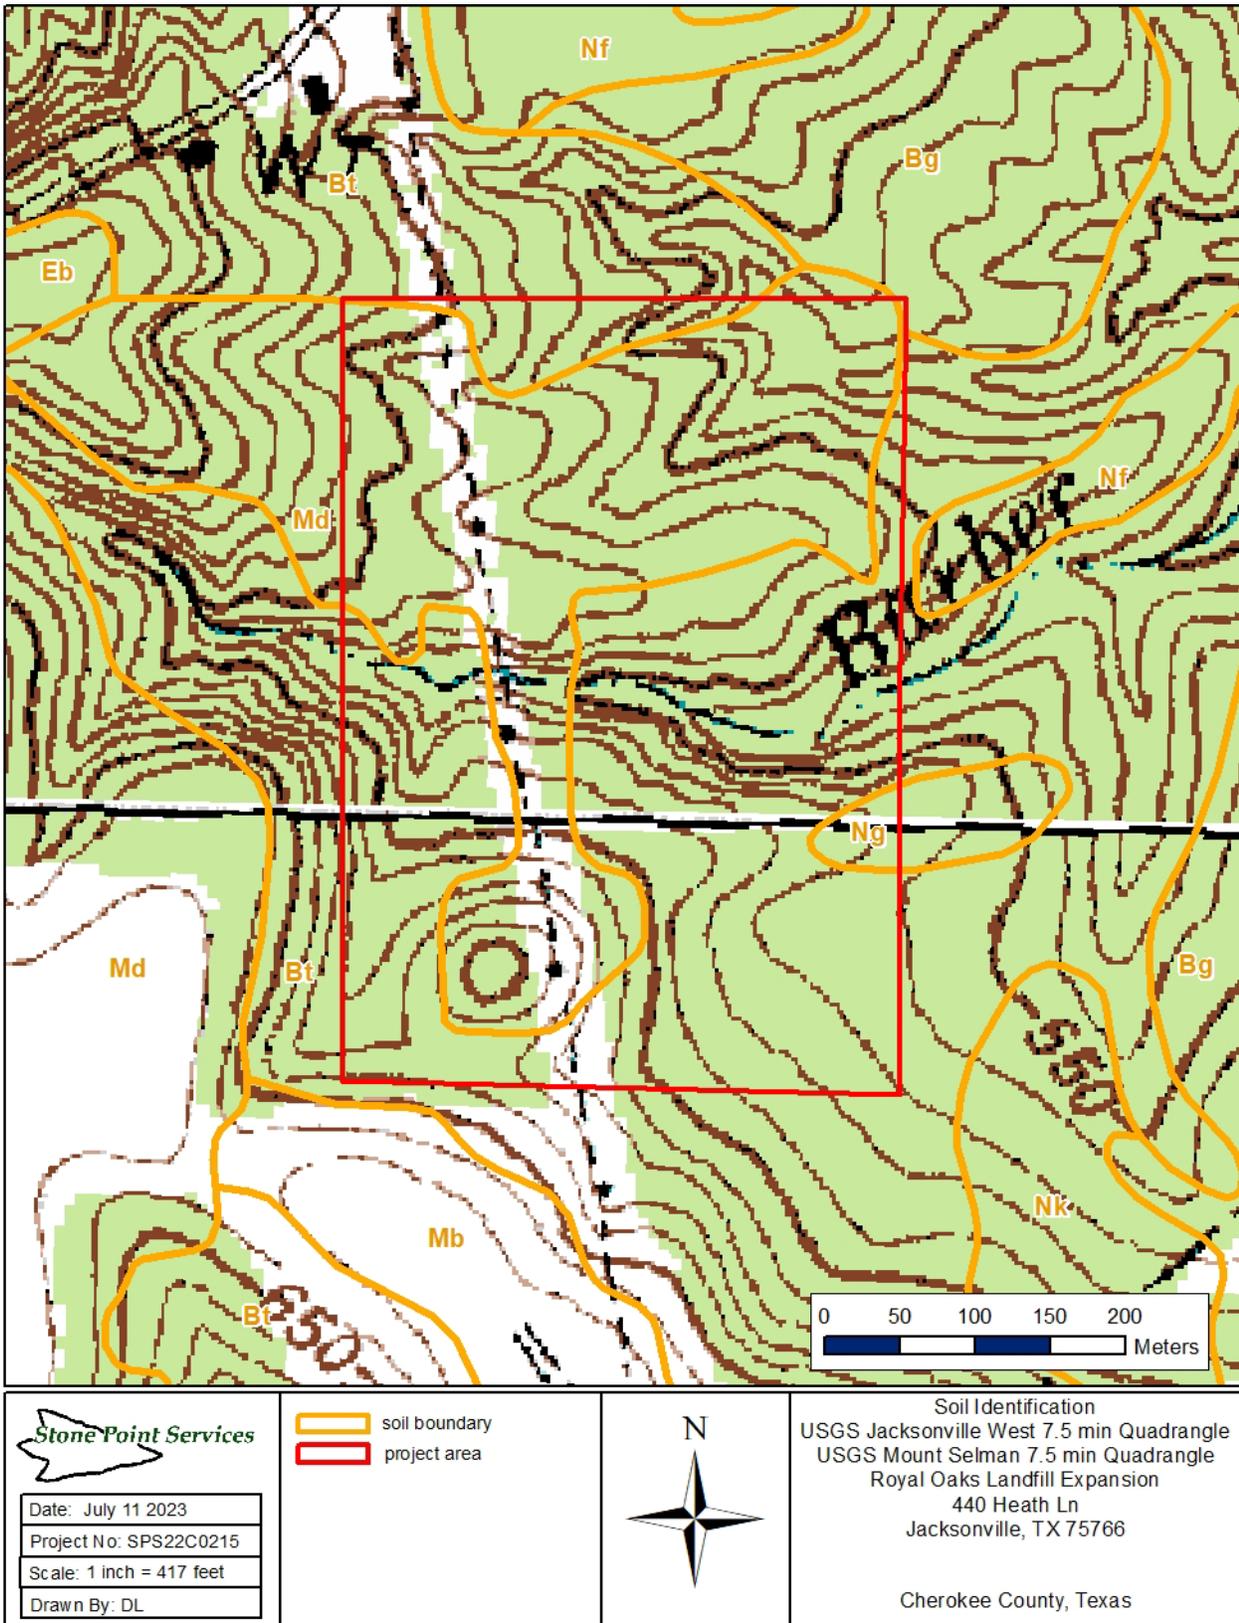
Figure 18: Soil types within the survey area.

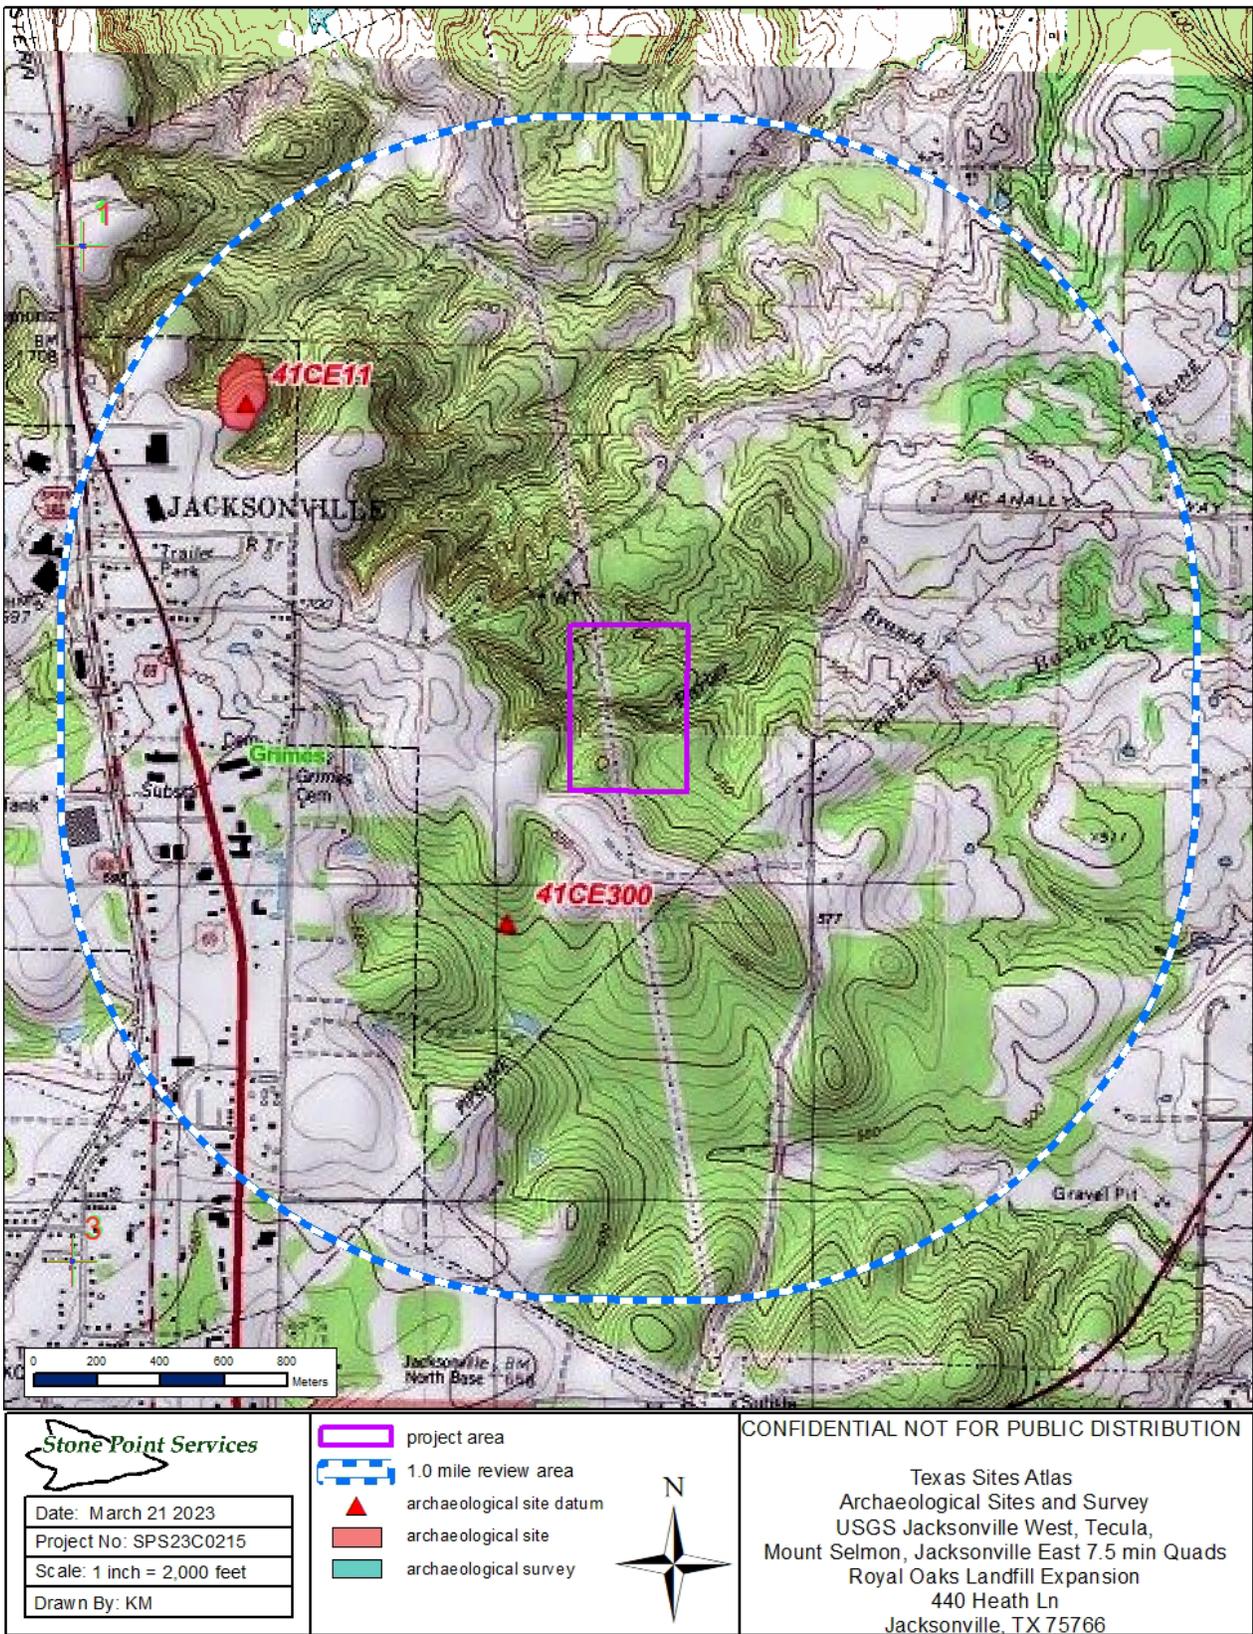
Figure 21: Archeological sites and surveys within 1.6-kilometers (1-mile) of the project area.

A Texas State Historic Preservation Office (SHPO) file review was also completed on March 21, 2023. Sources used for this review included the NRHP database, the Texas Archeological Sites Atlas for Cherokee County and the Texas Department of Transportation Historic Property List identified no NRHP listed or eligible historic resources, historic markers, or Recorded Texas Historic Landmarks were identified within 1.6-kilometers (1-mile) of the subject property. Grimes Cemetery is a Historic Texas Cemetery (CE-C004) located 0.885-kilometers (0.55-miles) west of the project area. There is also an unknown cemetery (not recorded as historic) located 0.756-kilometers (0.47-miles) west of the project area.

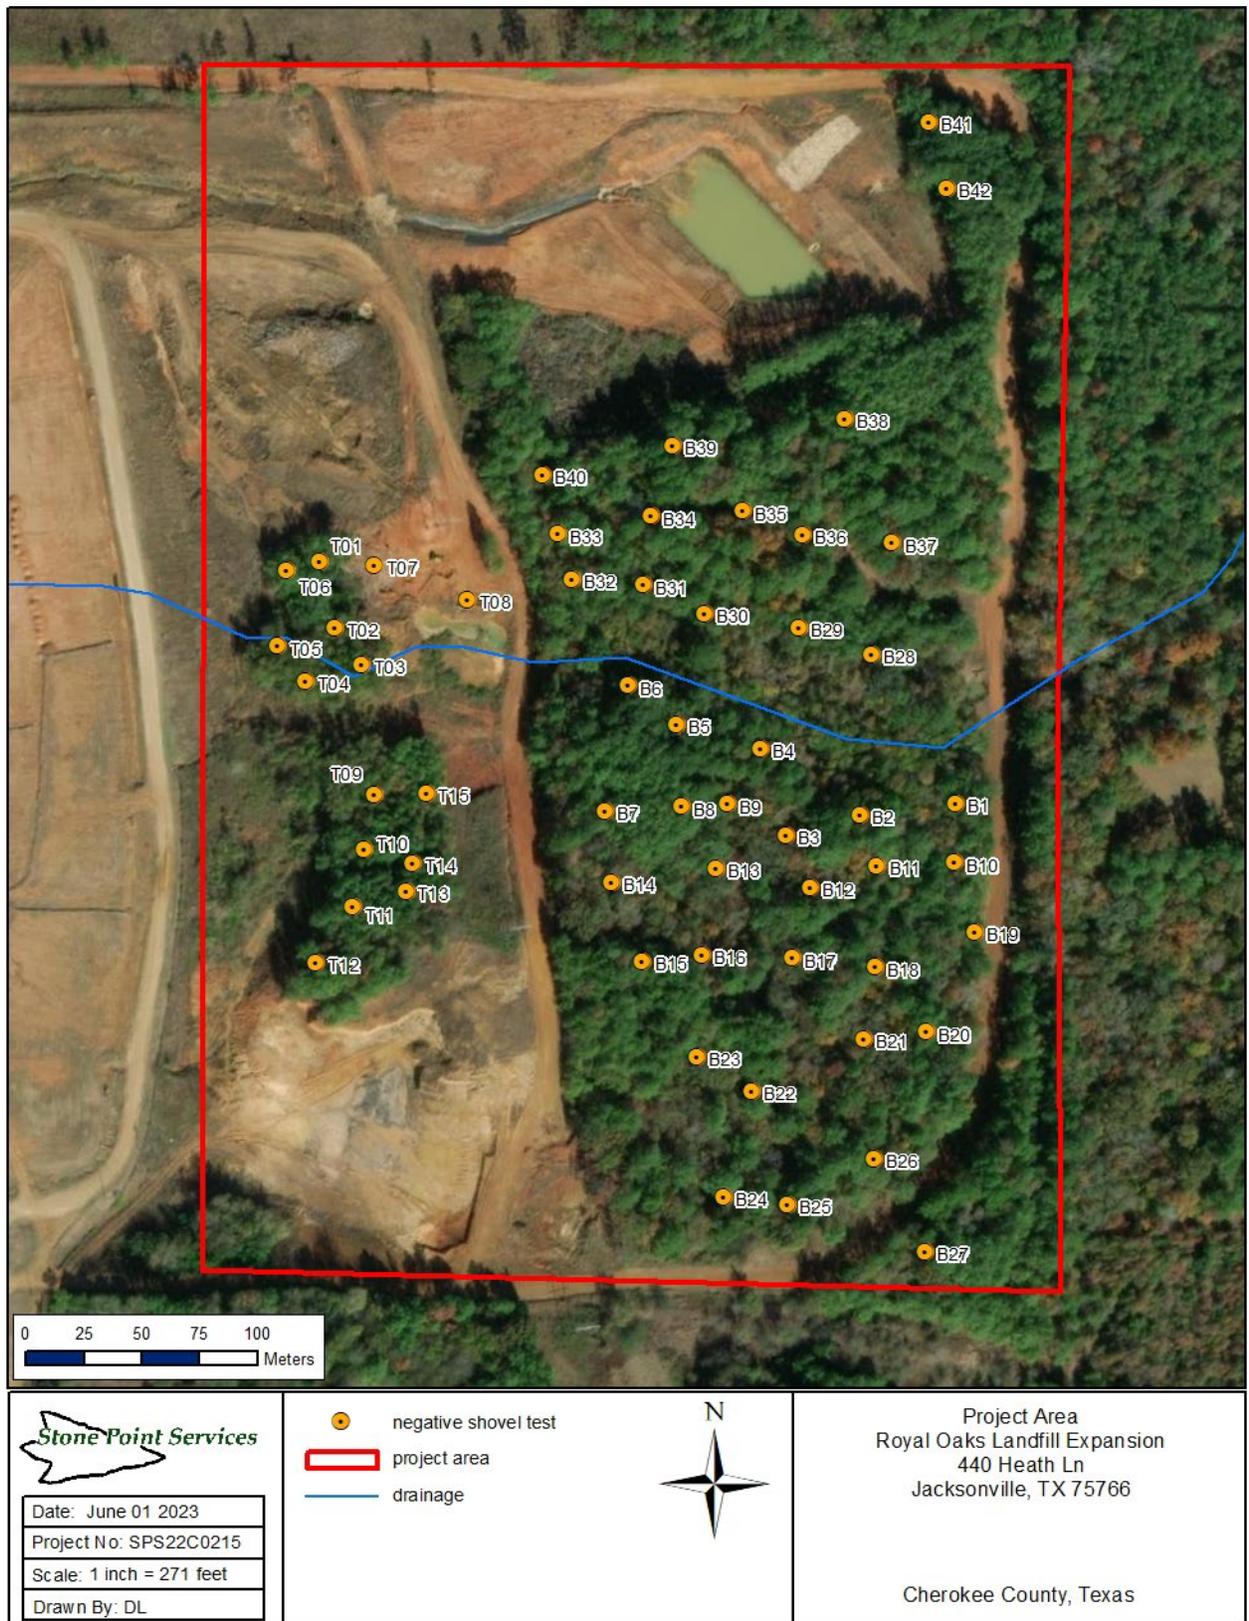
Figure 27: Project area map with project shovel test locations

Only one shovel test was placed in the Nacogdoches series (Figure 31) and it was too disturbed to show intact horizons.

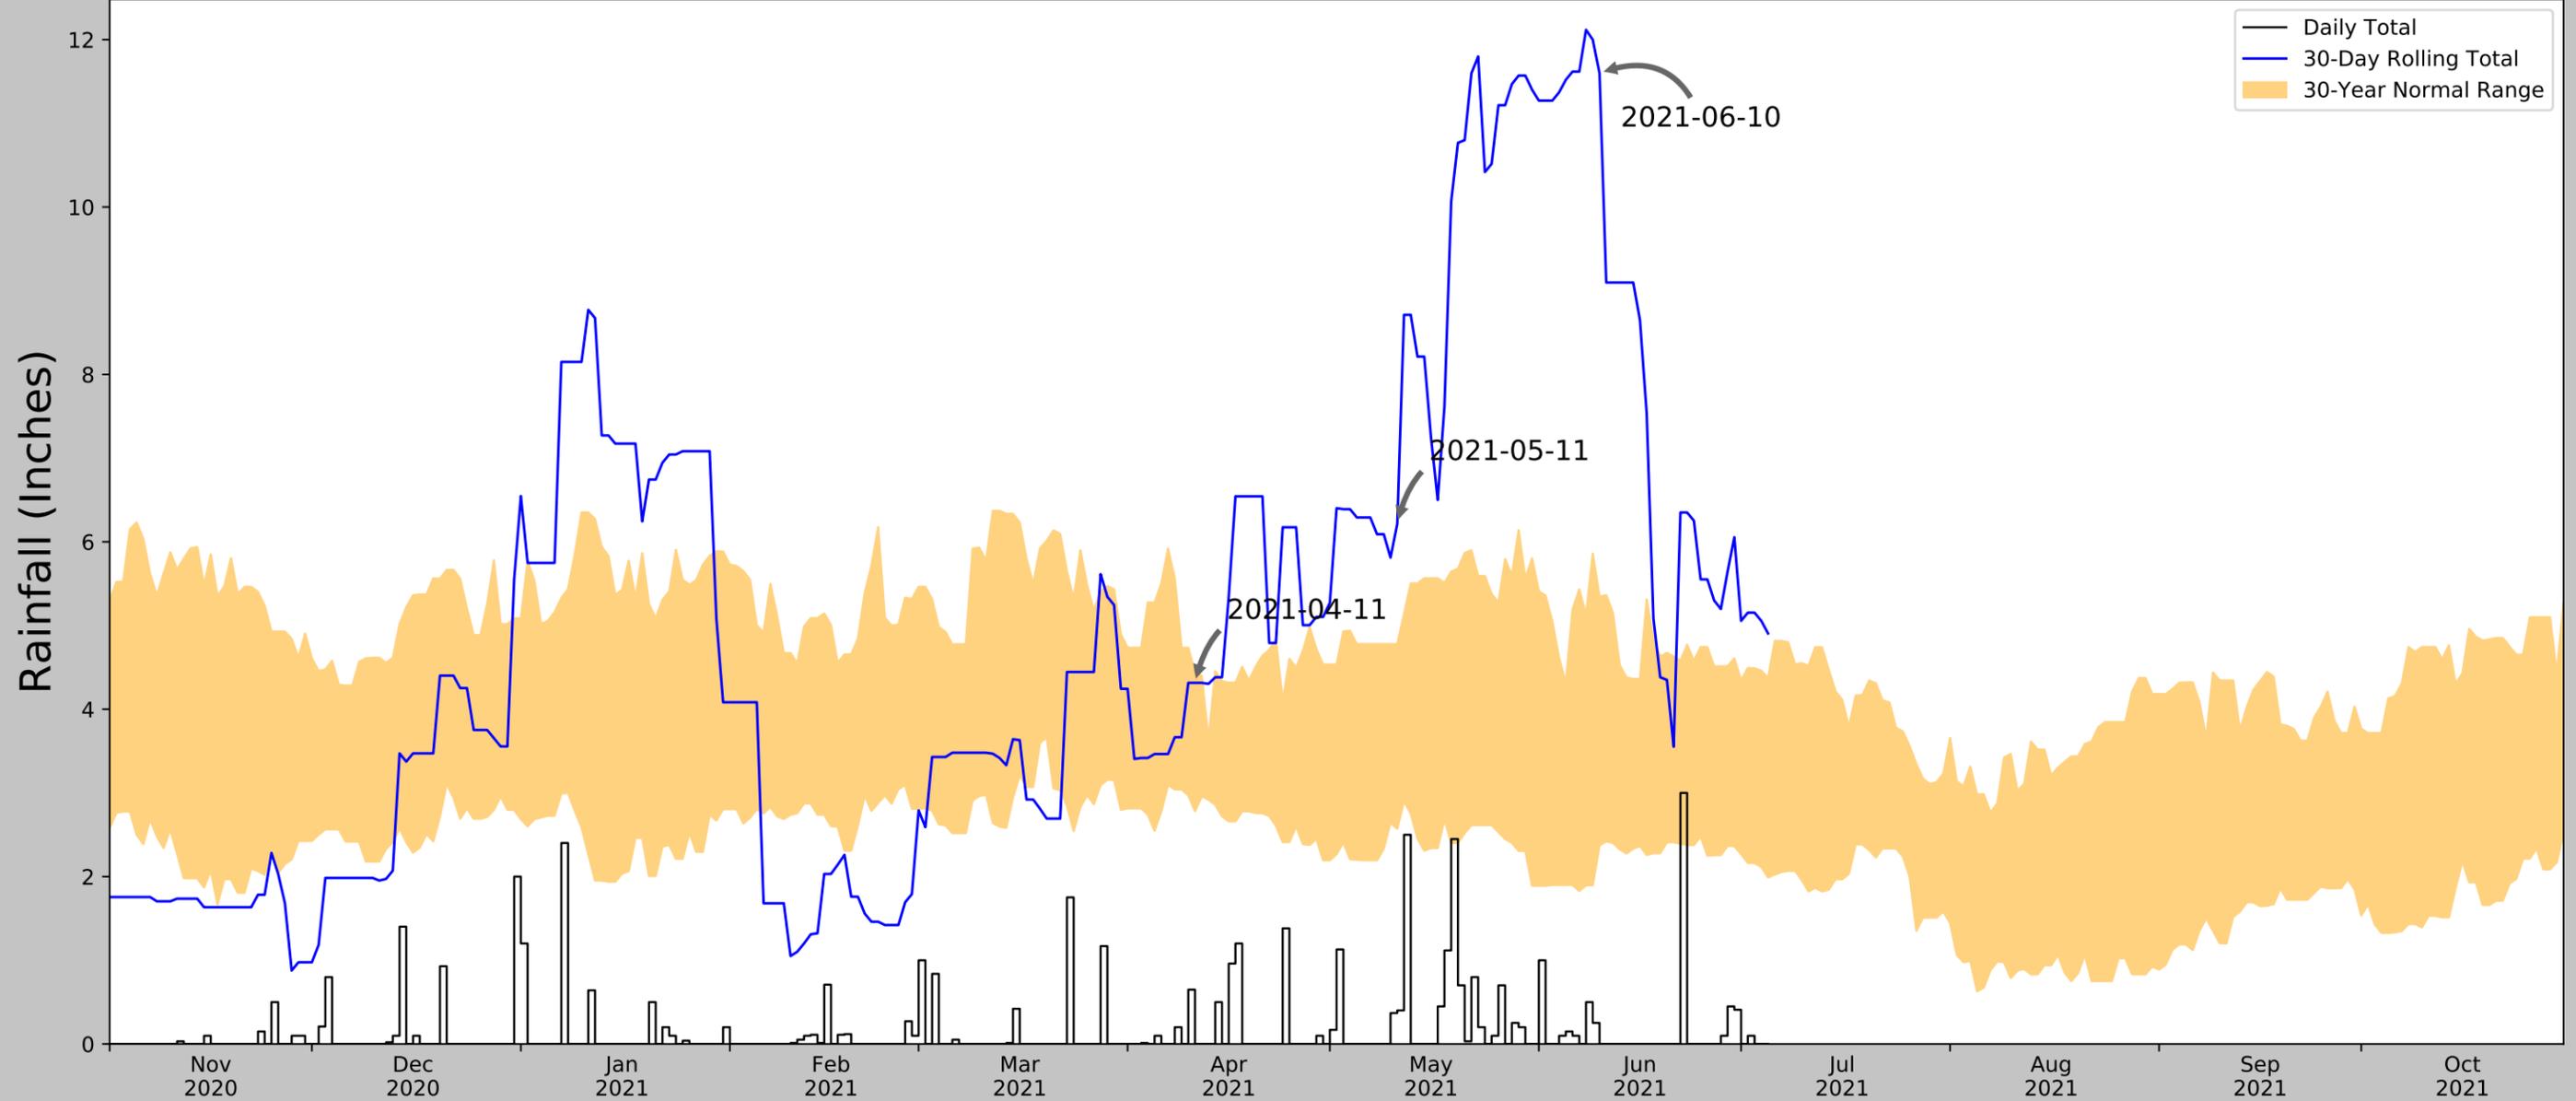
Antecedent Precipitation vs Normal Range based on NOAA's Daily Global Historical Climatology Network

Coordinates	32.000751, -95.262744
Observation Date	2021-06-10
Elevation (ft)	586.72
Drought Index (PDSI)	Moderate wetness (2021-05)
WebWIMP H ₂ O Balance	Dry Season

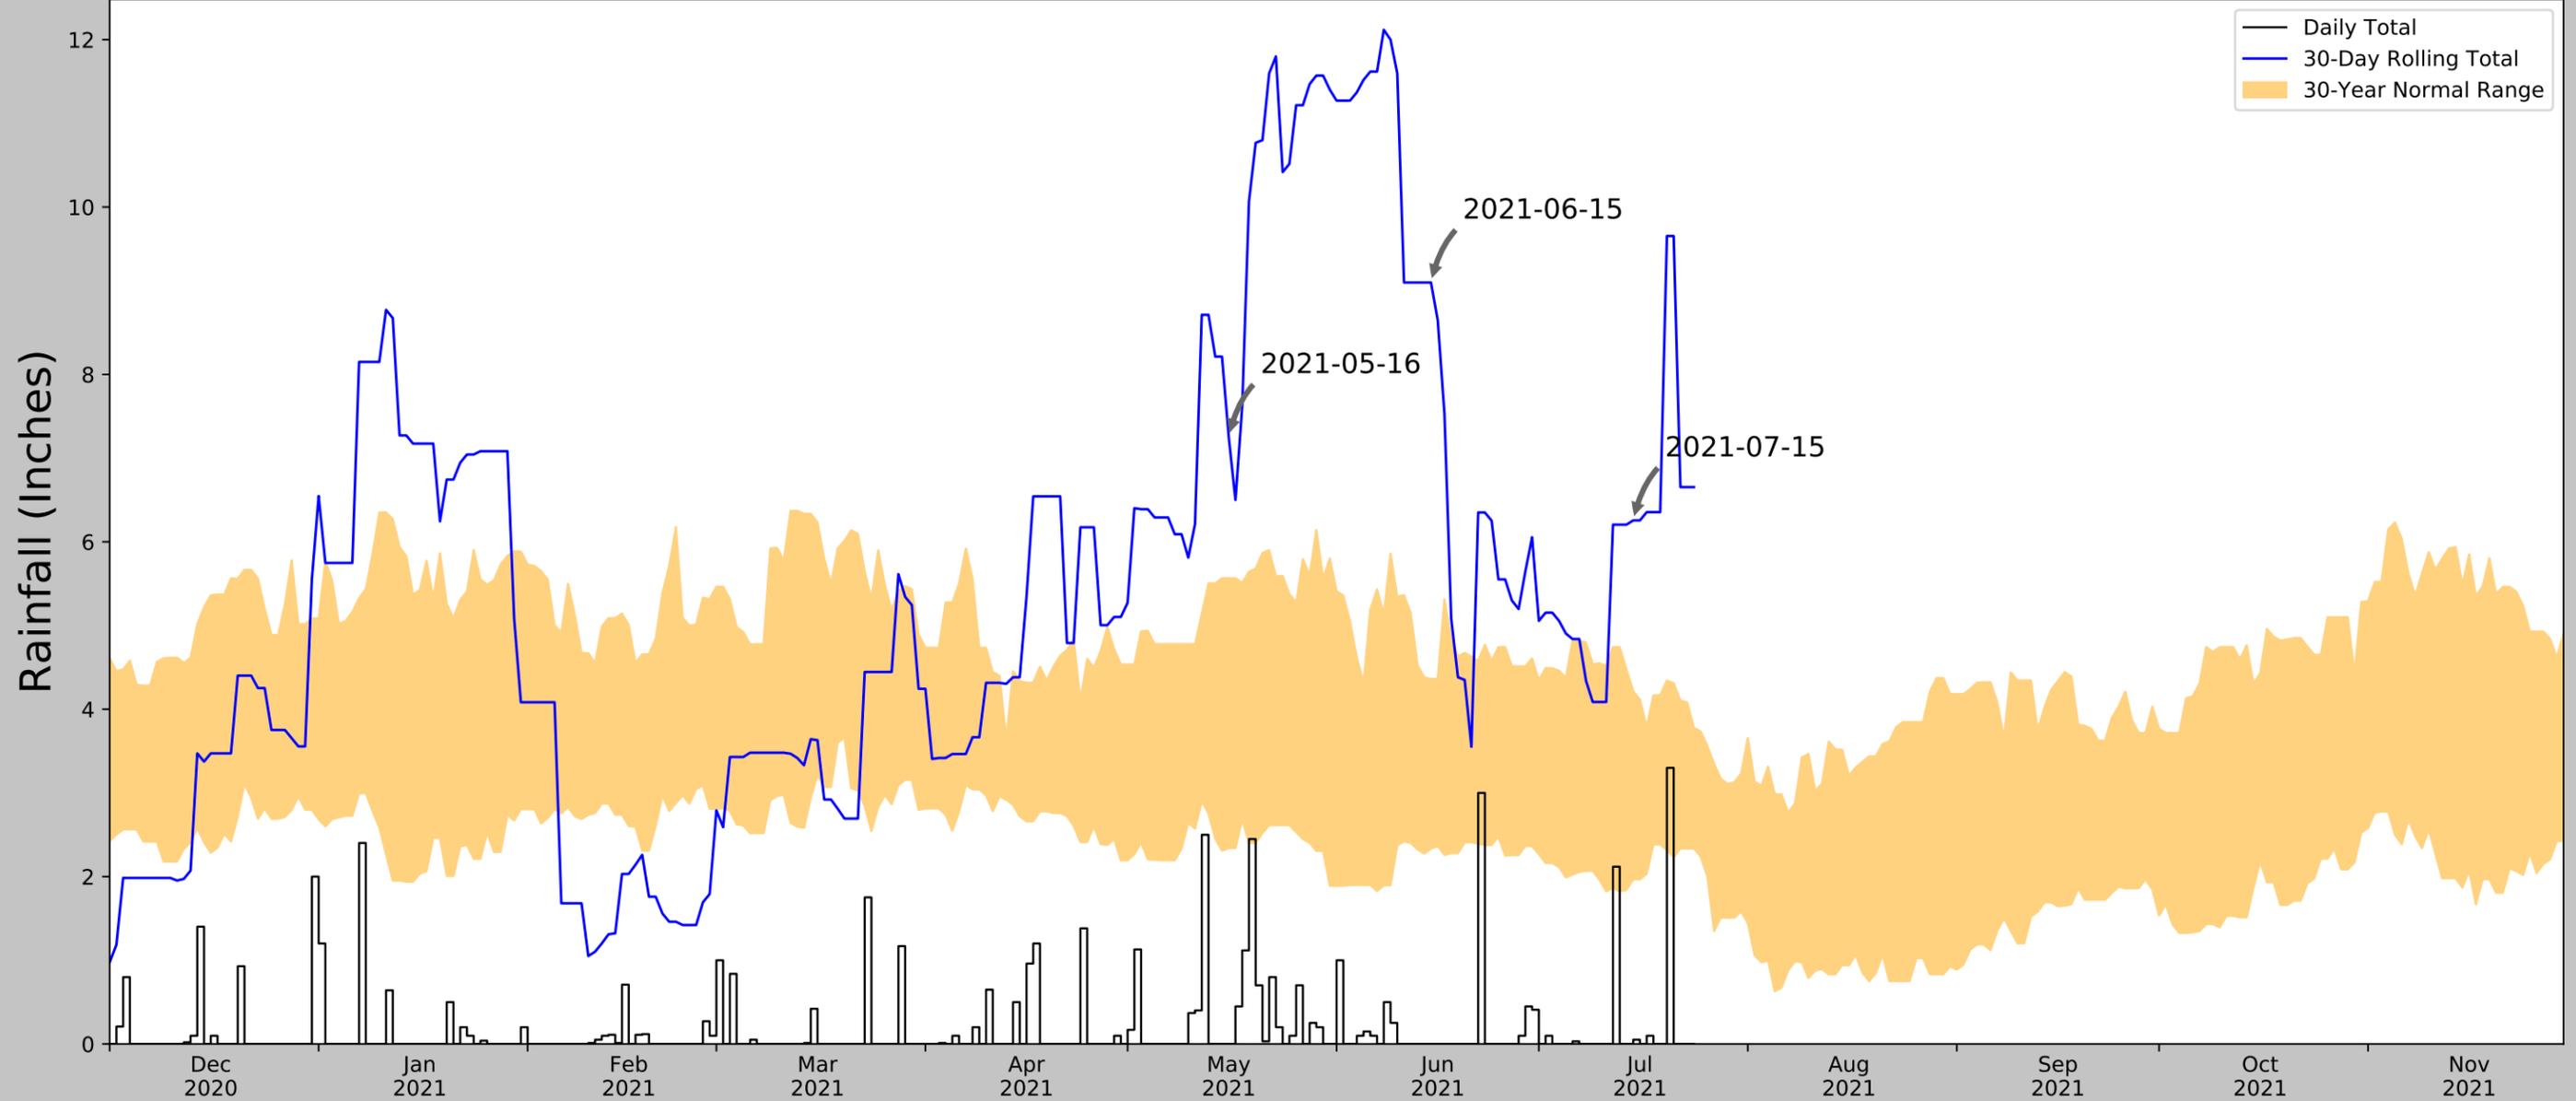
Antecedent Precipitation vs Normal Range based on NOAA's Daily Global Historical Climatology Network

Coordinates	32.000751, -95.262744
Observation Date	2021-07-15
Elevation (ft)	586.72
Drought Index (PDSI)	Moderate wetness (2021-06)
WebWIMP H ₂ O Balance	Dry Season

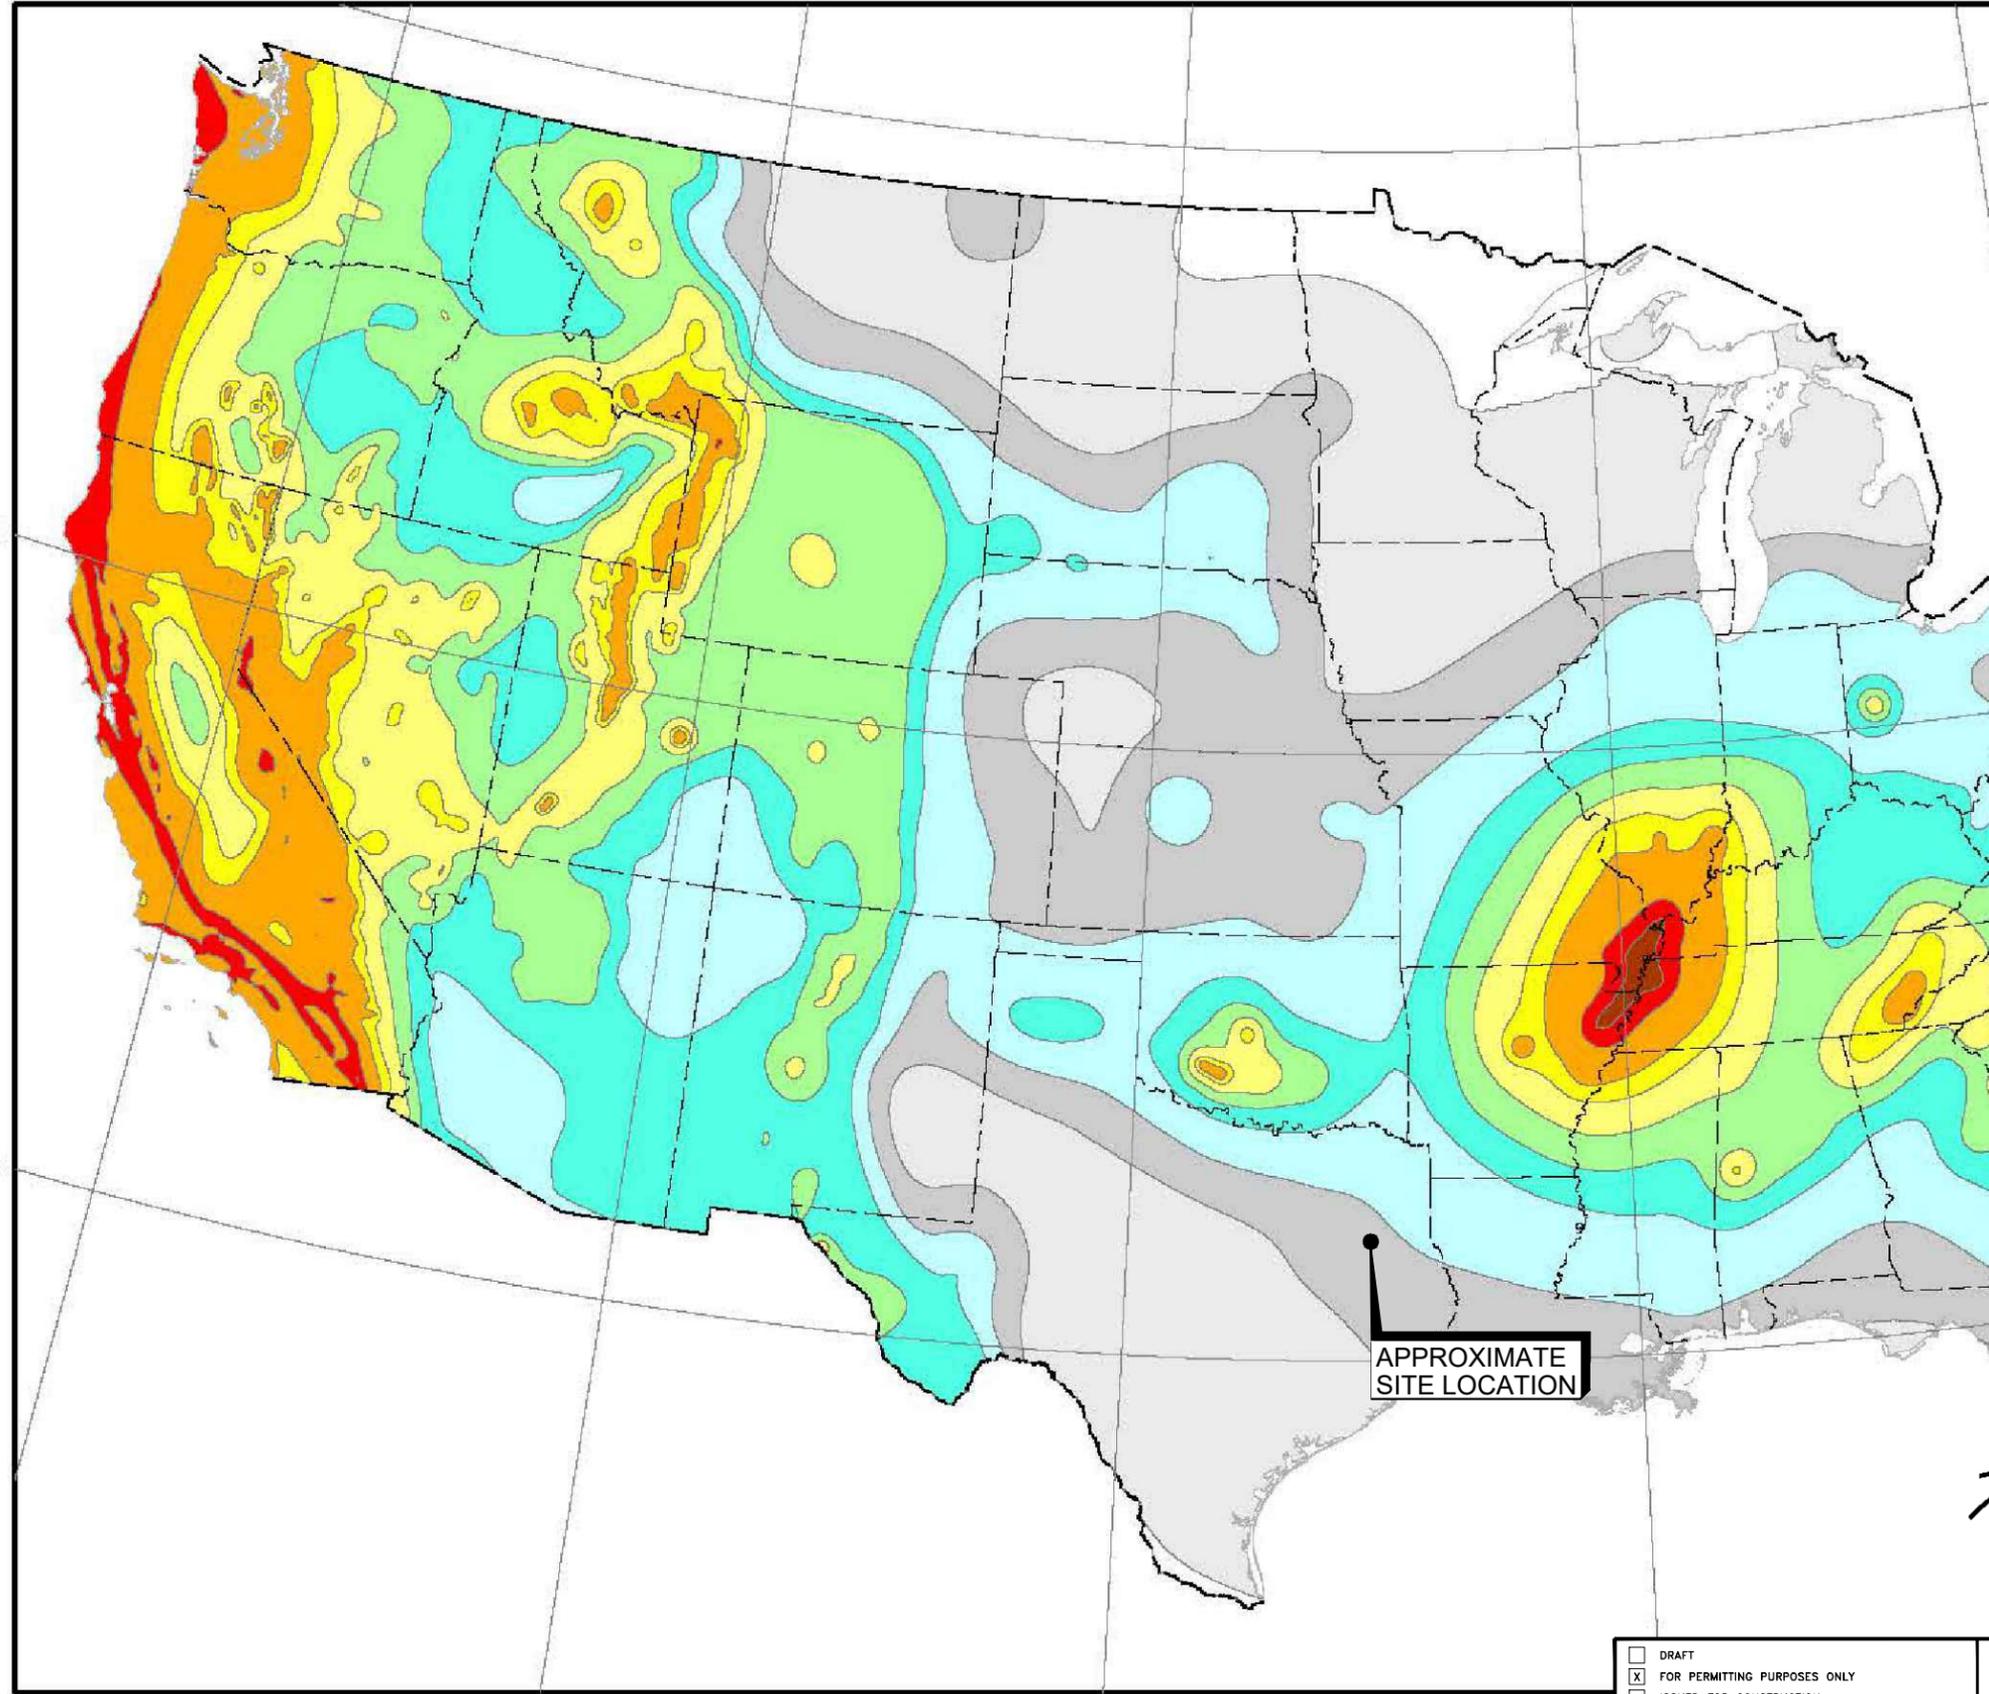
Peak horizontal acceleration (g)
